INDOOR AIR QUALITY ASSESSMENT

**Hopedale Junior/Senior High School
25 Adin Street
Hopedale, Massachusetts**

Prepared by:
Massachusetts Department of Public Health
Bureau of Environmental Health Assessment
June, 2000

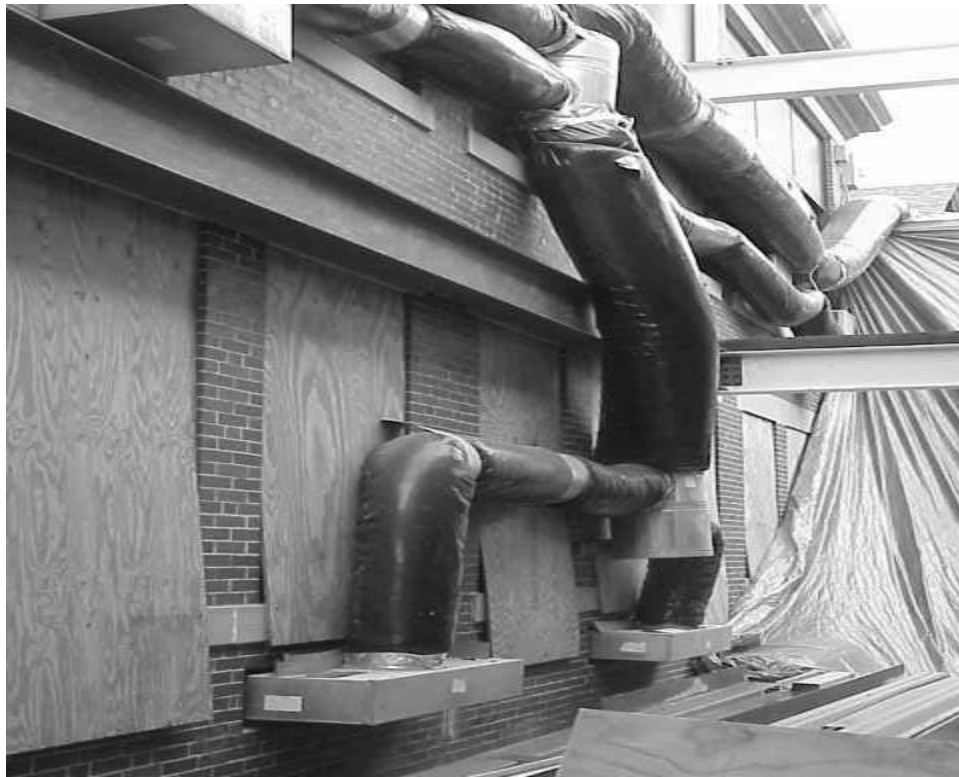
Picture 1

In an effort to prevent renovation generated pollutants from being entrained by univents of classrooms adjacent to the construction/renovations, flexible ductwork was installed over the fresh air intakes (see Picture 1). This ductwork extends over the edge of the building and terminates on the roof in a fan. While this temporary duct system will prevent the entrainment of pollutants from the renovation, it may not be sufficient to provide fresh air for these classrooms. Airflow decreases as the length of ductwork increases from ventilation fans. In addition, airflow is decreased roughly in half by every 90° angle that exists in ductwork. Most univents fans are approximately 3 feet from the fresh air intake. While these univents would be sufficient to draw air from this distance, the installation of ductwork over twenty feet from the univent fans would limit the draw of fresh air into these classrooms. In addition, the ductwork contains over 270° of angles. If the draw of fresh air by the univents at the fresh air intake were 100 percent, the introduction of the angles of this ductwork would reduce that draw to approximately 12.5 percent. Therefore the length of this ductwork combined with the angles within the ductwork would tend to limit the amount of fresh air that can be drawn by univents in the classrooms without some mechanical aid in addition to the rooftop unit. A break in this vent system (see Picture 2) and damage to the flexible ducts (see Picture 3) were also

Flexible Ductwork Attached to Univert Fresh Air Intakes to Avoid Entrainment of Construction/Renovation Pollutants

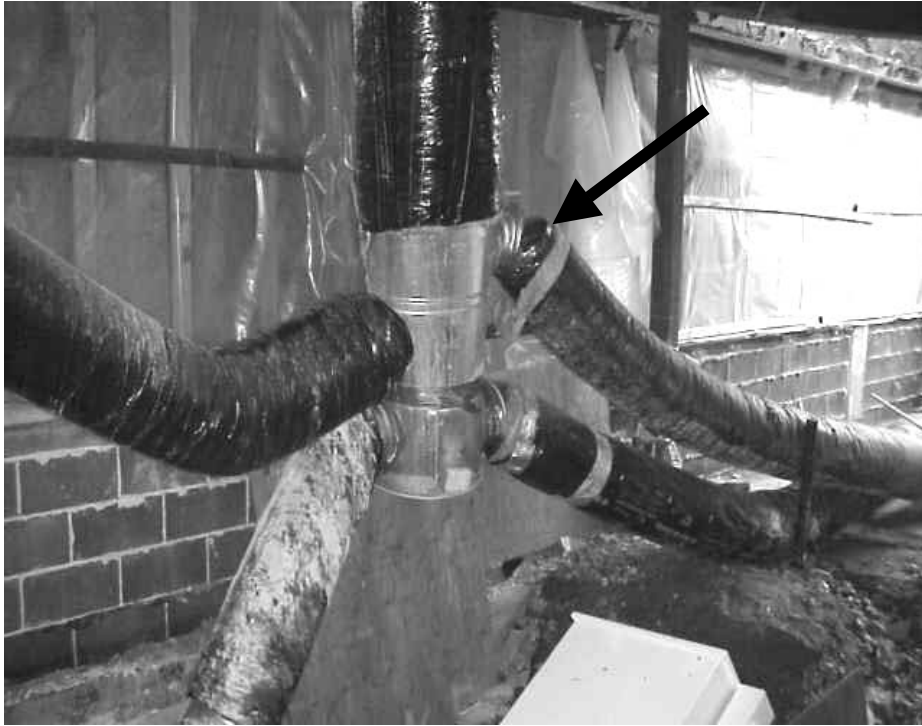
Picture 2

noted. Damage to this system may degrade the ability of the univents to draw fresh air as well as result in pollutants from the renovation areas to be entrained by operating univents and introduced into classrooms. The top floor of the 1929 building is serviced by a heating, ventilating and air-conditioning (HVAC) system that is connected to wall mounted vents by flexible ductwork in the attic.

Fresh Air Supply Ductwork, Note Partially Detached Flexible Ductwork

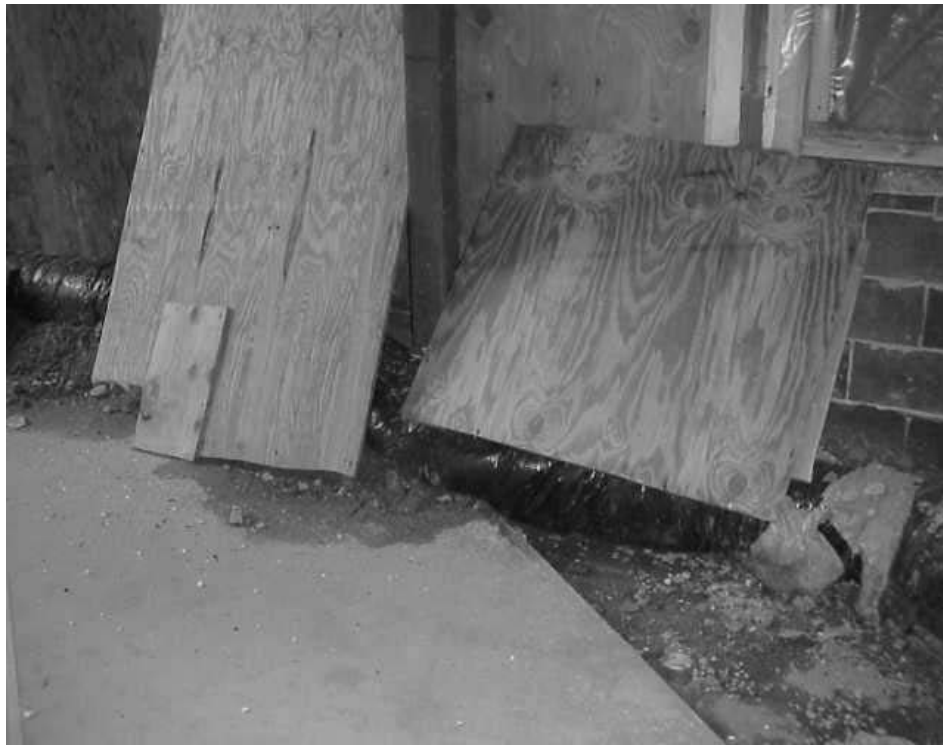
Picture 3

Flexible Duct Crushed under Plywood

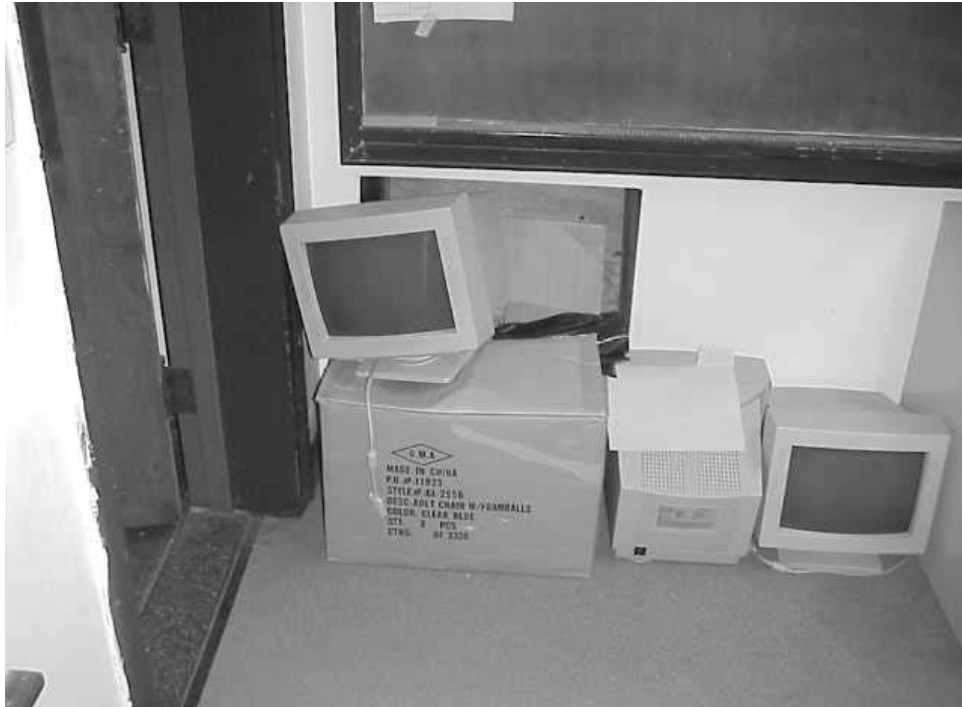
Picture 4

Exhaust ventilation consists of a series of gravity feed wall vents (see Picture 4) that are connected by airshafts to sheltered vents on the roof. No airflow was detected from these vents. In addition, a number of these vents were blocked with boxes and other materials, that can prevent airflow. If this system is not operating to its original function, airflow from the outside (called backdrafting) can penetrate into classrooms, carrying dirt/debris within the airshafts into classrooms. This unintended airflow can make temperature and fresh air control by univents difficult. Each of the vents terminates on the roof in a chimney-like structure. The location of the rooftop termination of these exhaust vents could not be determined, but it appears that previous renovations may have sealed these vents. It appears that a single roof duct terminus exists on the roof of the original school building (see Picture 5). Whether all exhaust ducts converge at the cupola could not be determined. Examination of the blueprints of the original building is needed to determine this condition. If open to the outdoors, these shafts should be sealed in classrooms and at the roof level to prevent backdrafting as well as preventing pests (birds, rodents, etc.) from entering occupied areas via the ventilation shaft.

Gravity Exhaust Vent Blocked with Boxes

6. Consider restoring exhaust ventilation to classrooms. If not feasible, seal exhaust vents in classrooms as well as the roof to prevent backdrafting and the egress of dirt, dust and/or odors into occupied areas.

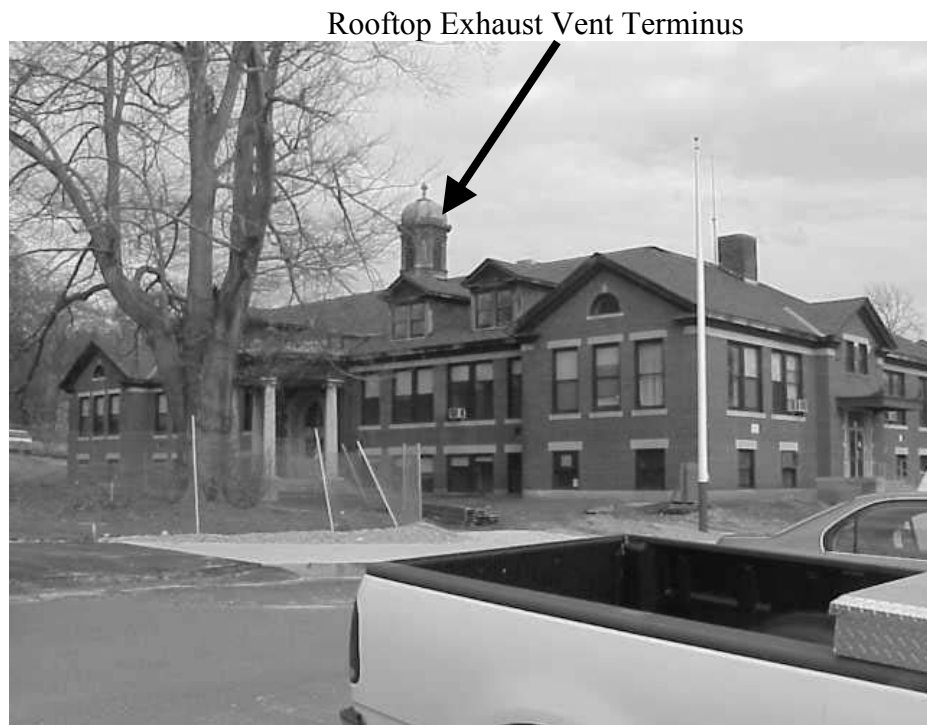
Picture 5

Exhaust Vent in Cupola of Building

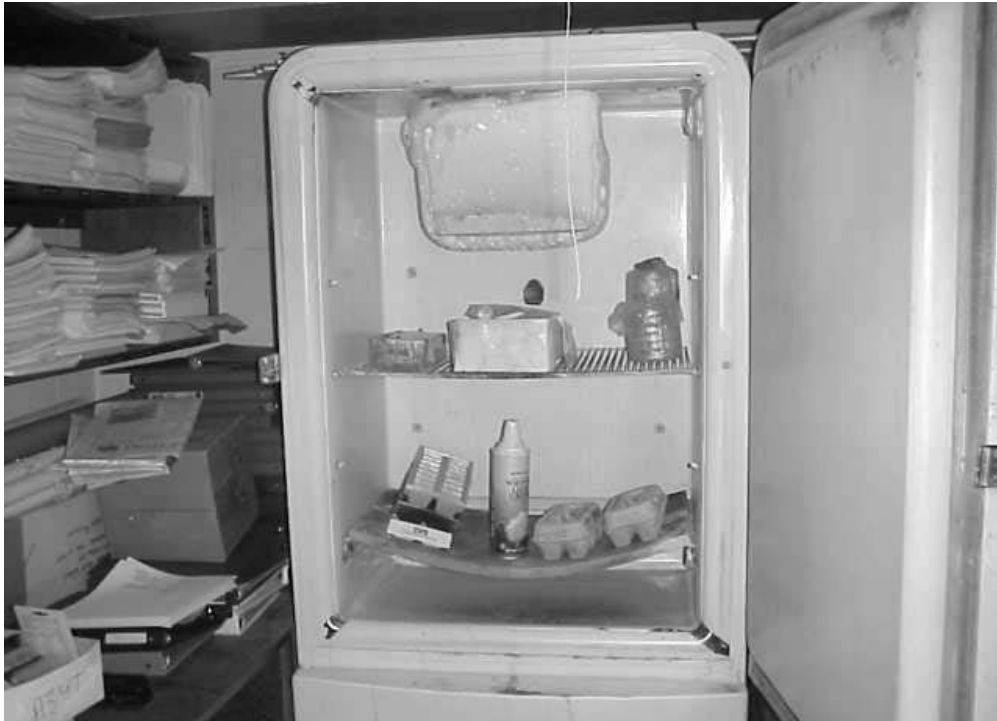
Picture 6

A pre-1960's style refrigerator was noted in the science storeroom (See Picture 6). A strong musty odor was noted around the refrigerator. Upon opening, several materials including a box of supplies (see Picture 7) were found colonized with mold.

Refrigerator in Science Storeroom

8. Remove moldy materials from the science storeroom refrigerator. Defrost and clean the interior of this refrigerator with an appropriate antimicrobial agent, then wipe down afterwards with soap and water.

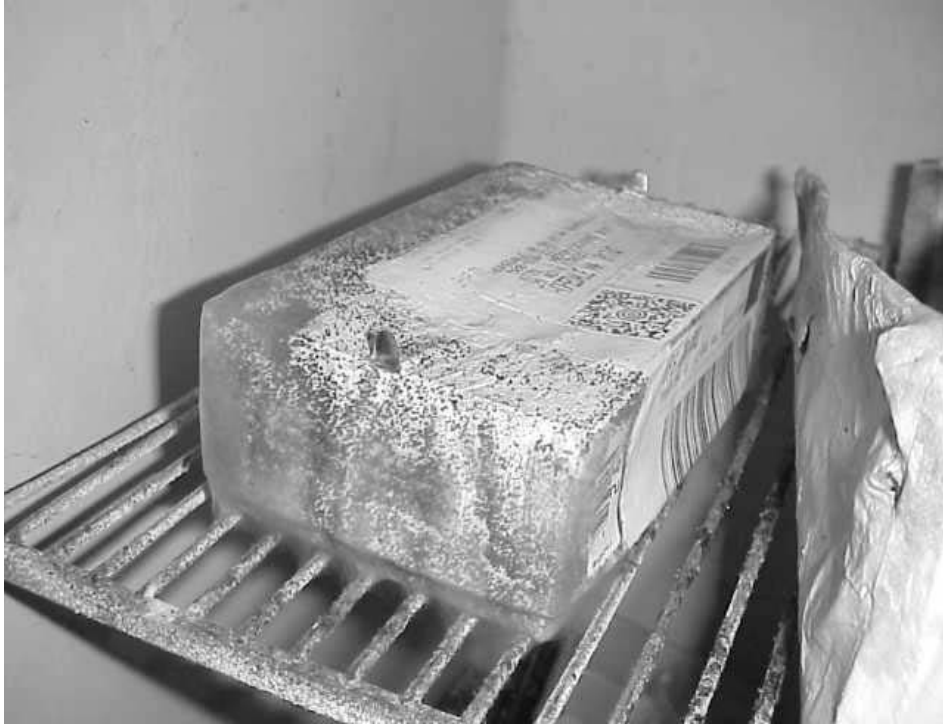
Picture 7

Mold Colonized Box in Refrigerator

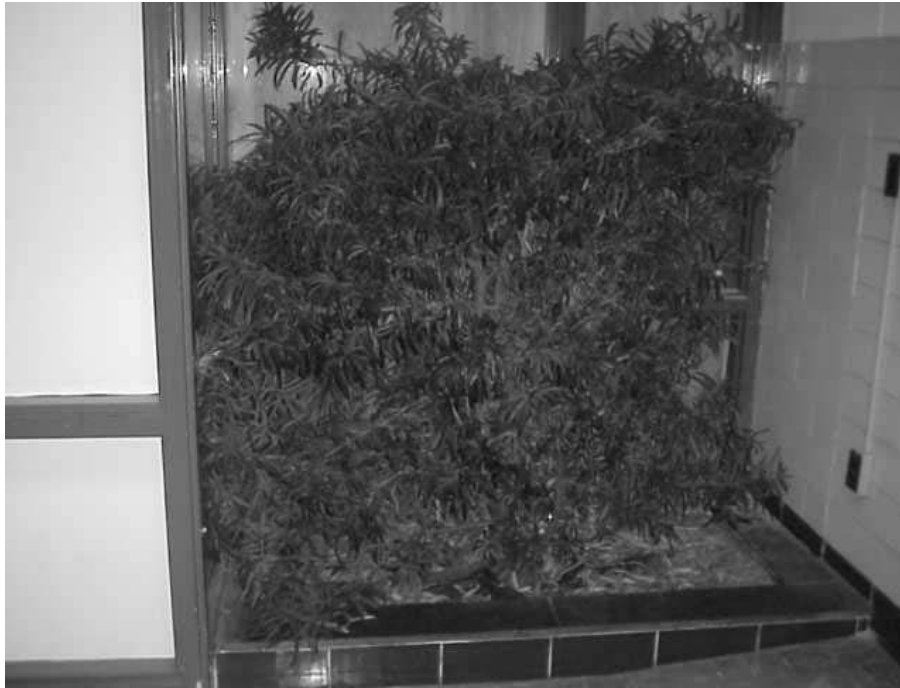
Picture 8

A hallway in the cafeteria contains an interior garden with living plants (see Picture 8). The internal garden appears to be in cement and it could not be determined if

these planters have adequate drainage. Plants can be a source of pollen and mold, which can be a respiratory irritant to some individuals. Plants should be properly maintained and have adequate drainage. The presence of a built-in heating vent located in the front of the garden can serve to aerosolize particulates, pollen, dirt, mold and/or spores present in this planter.

Indoor Planter in Brick

11. Remove plants from the indoor planter in the hallway and examine the base of the planter for appropriate drainage, water leaks and microbial growth. If microbial growth is present, disinfect non-porous surfaces with an appropriate antimicrobial agent.

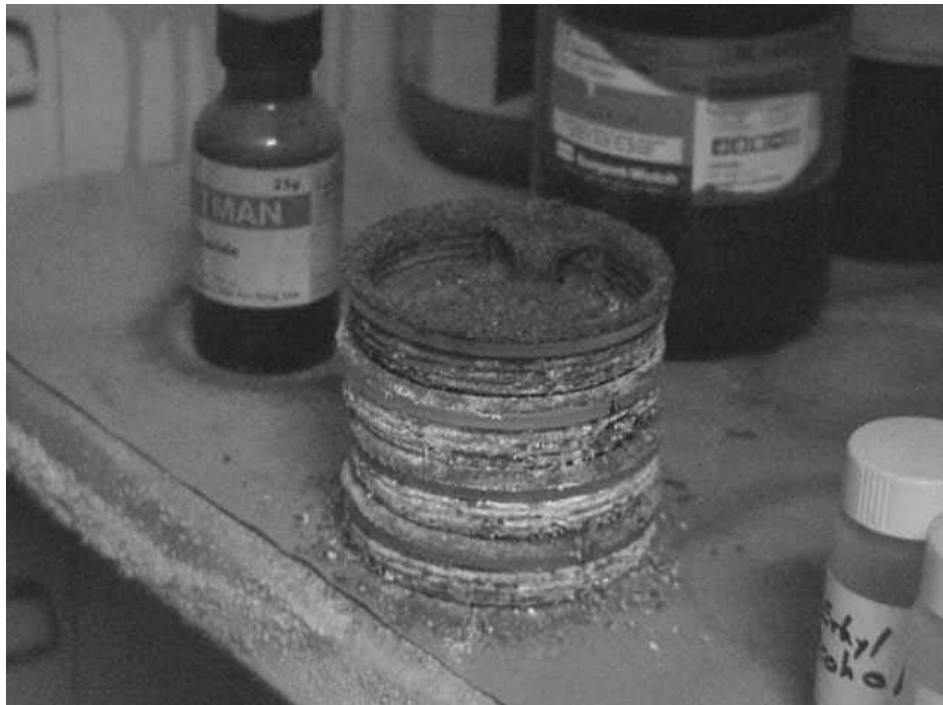
Picture 9

1. A heavily corroded container of an unlabeled material is stored in the flameproof cabinet (see Picture 9).
2. The chemical storeroom contained an operating chemical hood. Stored in this chemical hood were several bottles of acids (see Picture 10). The handles to the window sash of the chemical hood are corroded, (see Picture 11) which indicates that chemical vapors have escaped from the chemical hood at some previous date to corrode the exterior of this equipment. The purpose of chemical hoods is to draw aerosolized chemical vapors and odors from the work area out of the building. Chemical hoods should not be used for storage of unattended materials because this equipment can be deactivated during off-hours (Rose, S. L., 1984). If the chemical hood is deactivated, off-gassing material can penetrate into adjacent areas. Chemical hoods should be on at all times that chemicals are within the equipment. It is also good chemical hygiene practice to return stock bottles back to the storage cabinet after use.

Unlabelled, Corroded Container in Flameproof Cabinet

9. Have a chemical inventory done in all storage areas and classrooms. Discard hazardous materials or empty containers of hazardous materials in a manner consistent with environmental statutes and regulations. Follow proper procedures for storing and securing hazardous materials. Obtain Material Safety Data Sheets (MSDS') for chemicals from manufacturers or suppliers.

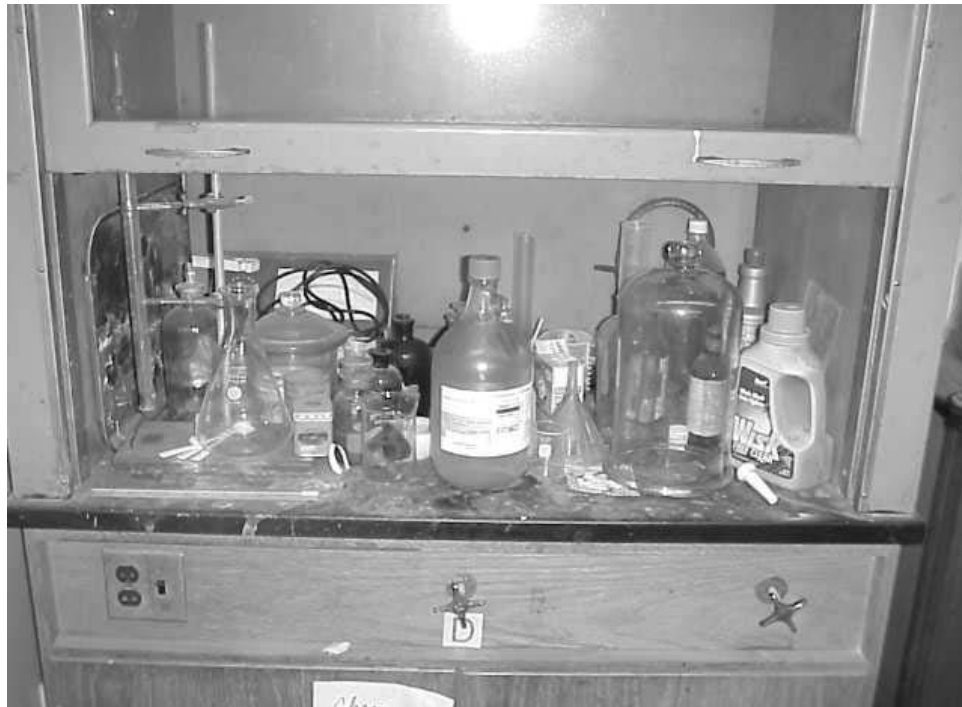
Picture 10

Chemical Hood in Chemistry Room with Stored Chemicals

13. Properly store chemicals and cleaning products.
14. Seal utility holes and replace missing ceiling tiles to prevent egress of odors, fumes and vapors between rooms and floors.

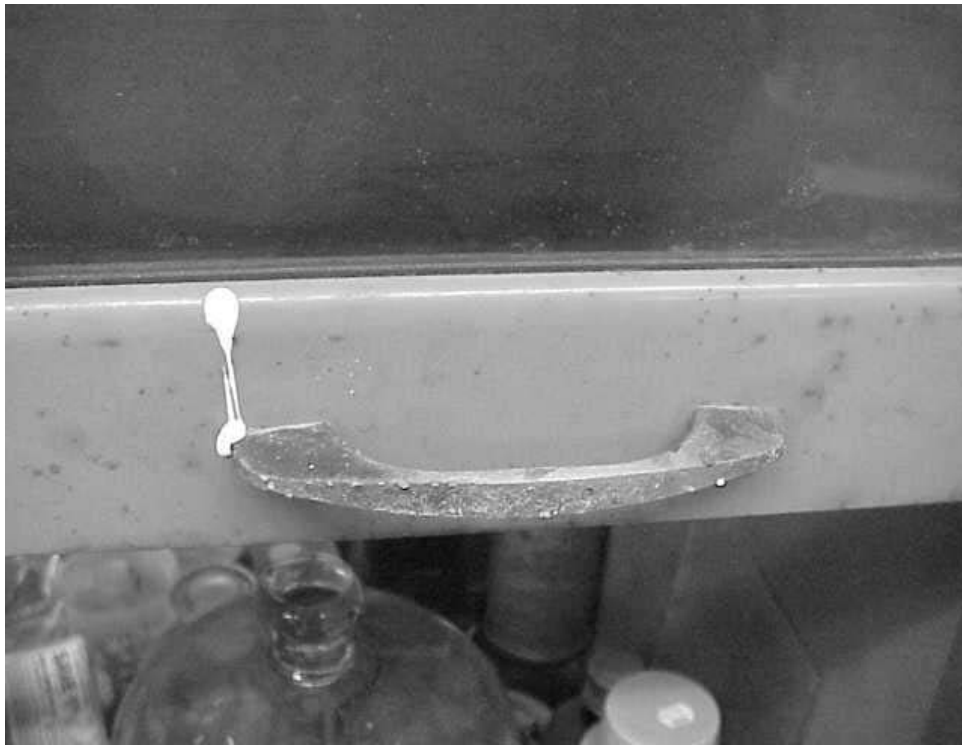
Picture 11

Handle to Chemical Hood Sash, Note Corrosion

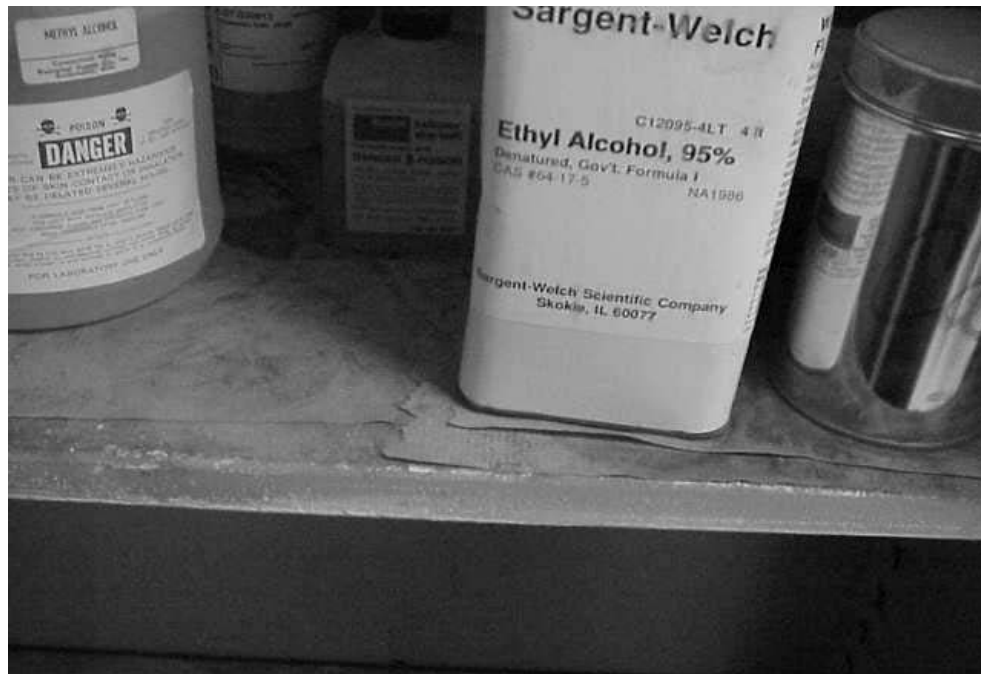
Picture 12

3. The interior walls underneath the shelves and doors of the flammable storage cabinet were heavily corroded, which can indicate off-gassing of chemicals from improperly sealed containers. Paper covers each shelf (see Picture 12). Paper can absorb chemicals and serve as a source of off-gassing for these materials.

**Paper Lining on Shelves of Flameproof Cabinet,
Note Discoloration of Paper That Indicate Leakage**

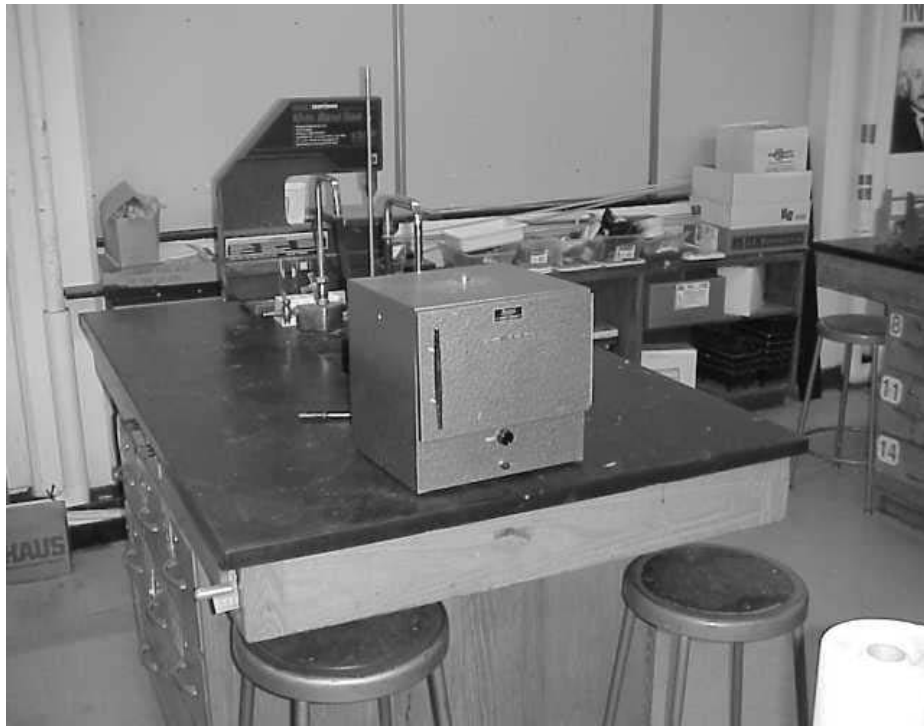
Picture 13

4. The chemistry lab was observed to have an incubator. Incubators are used for growing biological samples and have a vent at the top of its case (see Picture 13).

Incubator in Chemistry Room

Incubation should be done in an area with adequate local exhaust ventilation to prevent the spread of biological contamination from the incubators.

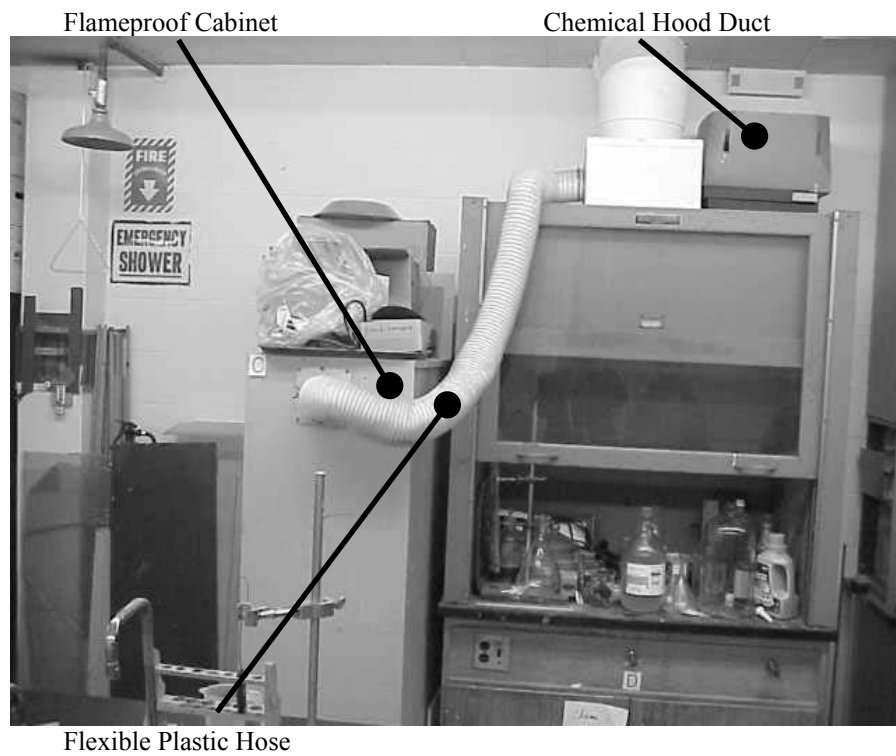
Picture 1

The Massachusetts Department of Public Health, Bureau of Environmental Health Assessment conducted an indoor air quality assessment at the Hopedale Junior/Senior High School on March 29, 2000. During the course of this assessment (conducted with Leonard Izzo of the Hopedale Board of Health) conditions in chemistry classrooms at the high school were evaluated. This area has a flammables storage cabinet that contains a number of volatile organic compounds (VOCs). Of concern is the connection of this cabinet to the ductwork of the chemical hood in this classroom by a flexible plastic hose (see Pictures 1 through 3).

The connection of these flammables storage cabinets with these vent hoses have, in the BEHA's opinion, created conditions that are an immediate danger to health and safety because of the breach of the integrity of the flammables storage cabinet.

Flameproof Cabinet Connected To Chemical Hood Duct by A Plastic Flexible Hose

1. Disconnect the flexible hose from the flammables storage cabinet. Reseal the bungholes of the flammables storage cabinet with the original bungs. If the original bungs cannot be located, contact the cabinet manufacturer to obtain replacements.
2. Reseal the ductwork of the chemical hood to render this duct airtight.

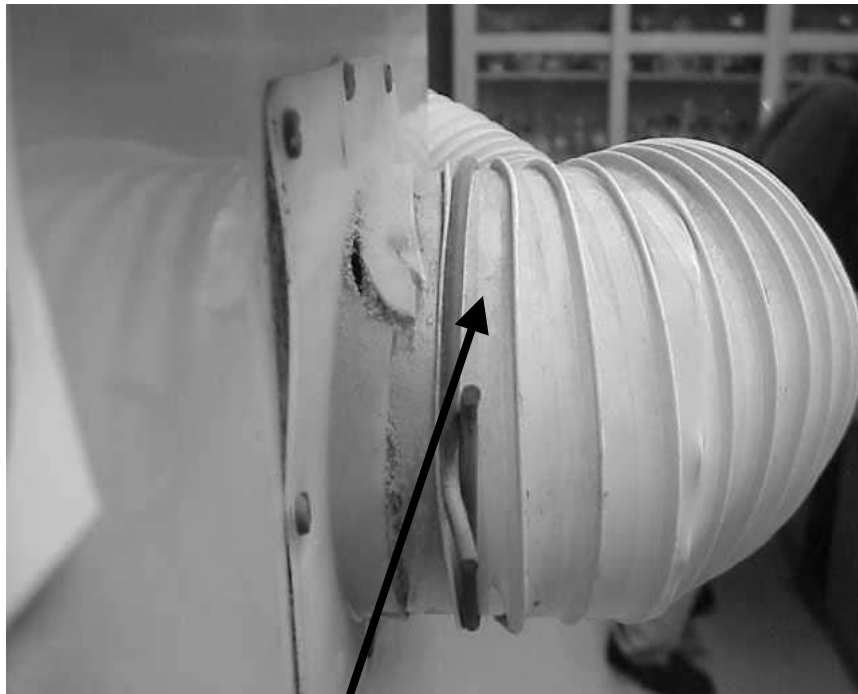
Picture 3

Tear In Material

Tear in Connection of Flexible Hose

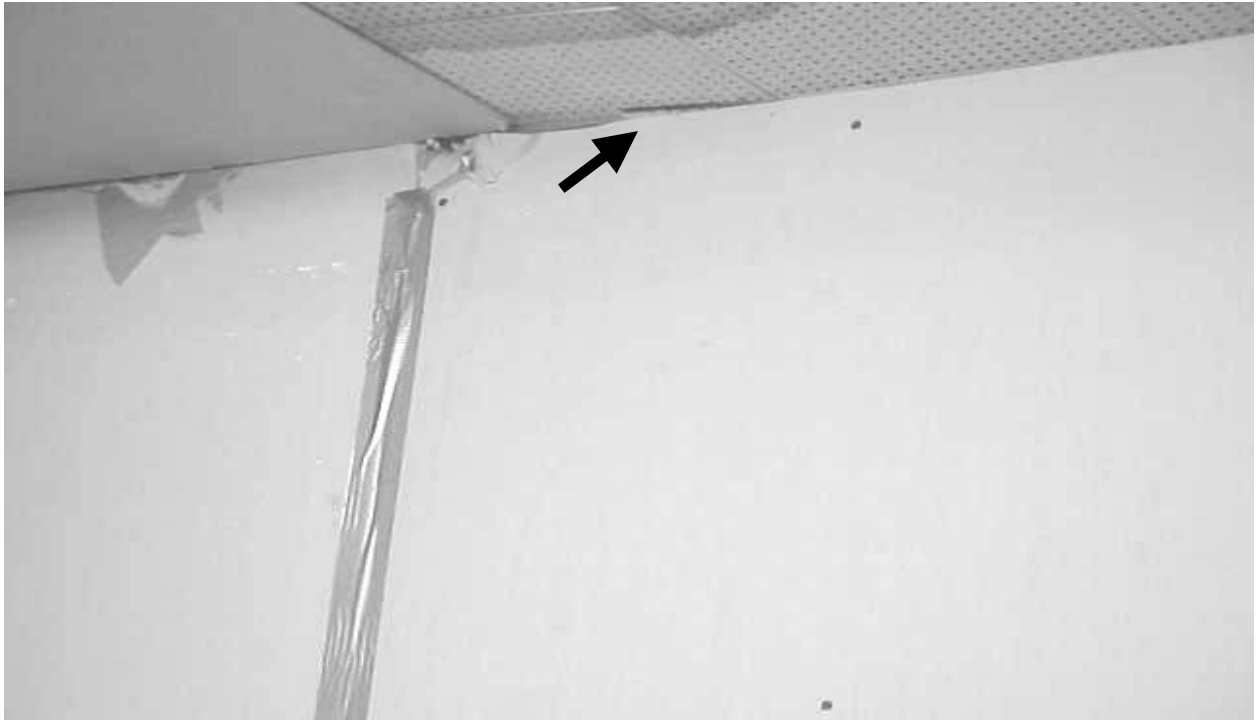
Picture 2

Spaces in temporary walls were observed (see Pictures 2 through 4). These spaces in containment areas may allow pollutants to migrate into occupied areas in the school. BEHA staff recommended that spaces around containment walls be sealed with duct tape. BEHA staff also recommended that containment walls be covered with plastic sheeting and duct tape to provide a secondary barrier.

**Gypsum Board Containment Wall Erected in Classroom
Note the Wall/Ceiling Junction Is Not Sealed with Duct Tape**

8. Seal utility holes, spaces in roof decking and temporary walls to eliminate pollutant paths of migration. Seal holes created by missing tiles in ceiling temporarily to prevent renovation pollutant migration.

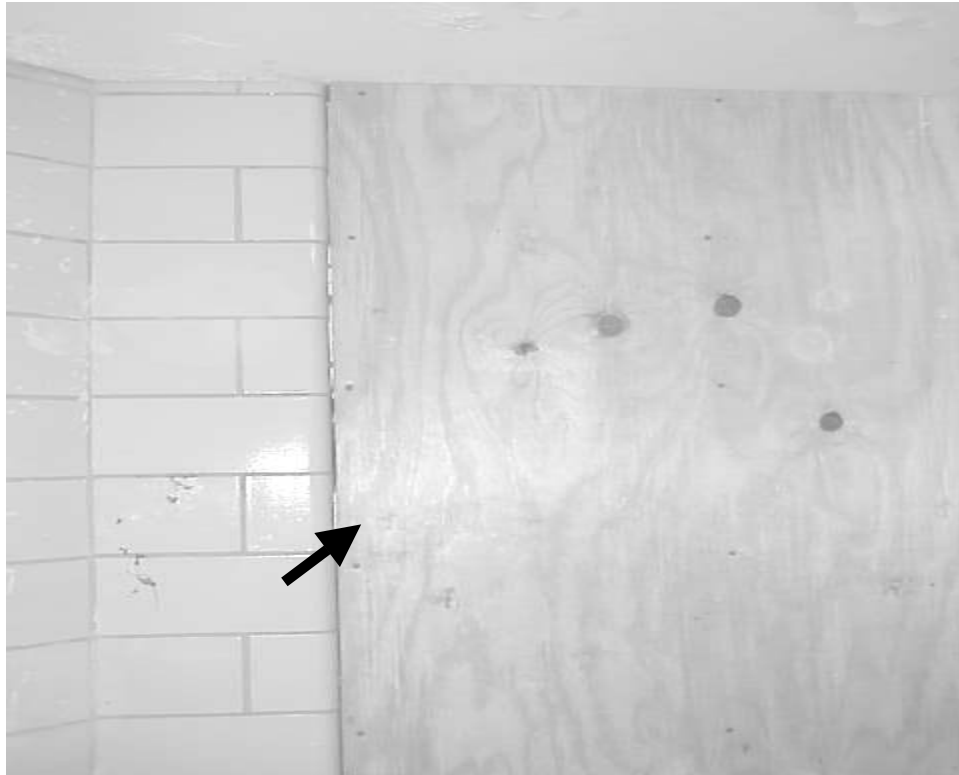
Picture 3

**Spaces Noted around Plywood Containment Wall
in South West First Floor Corridor**

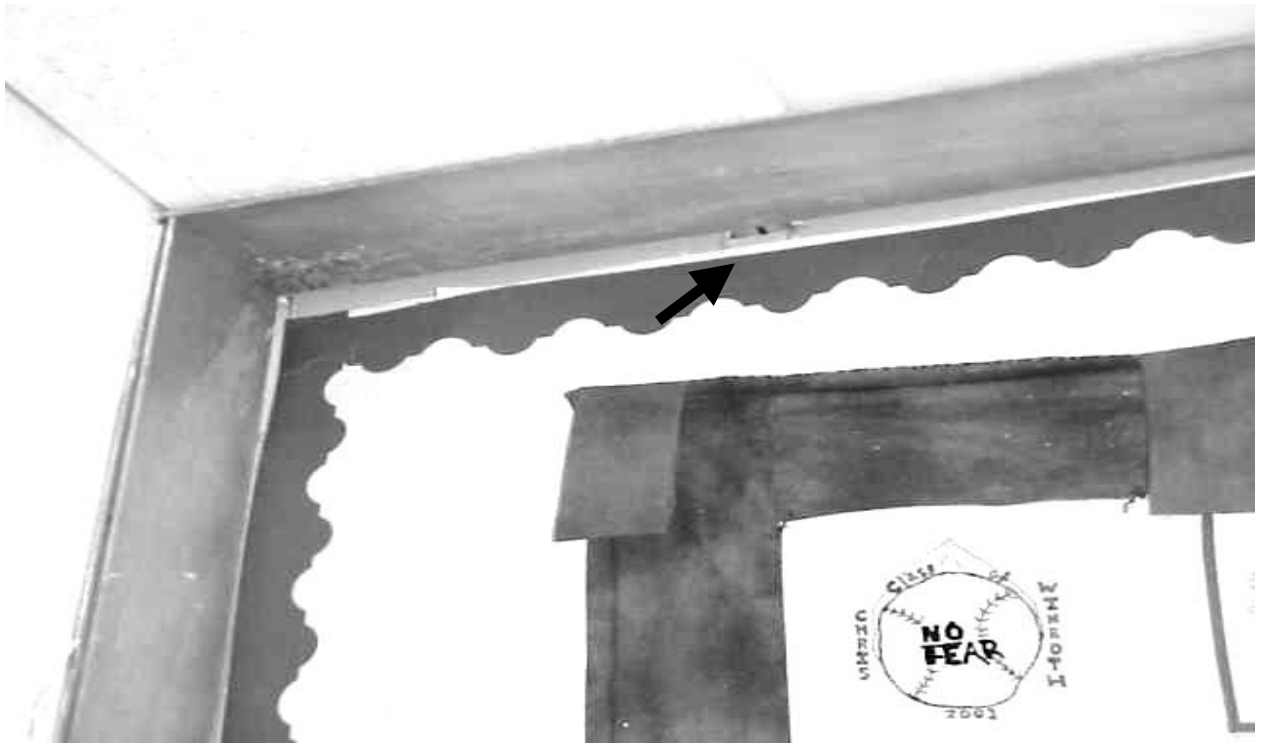
Picture 4

Hole Noted in Containment Wall Adjacent to the Ceiling

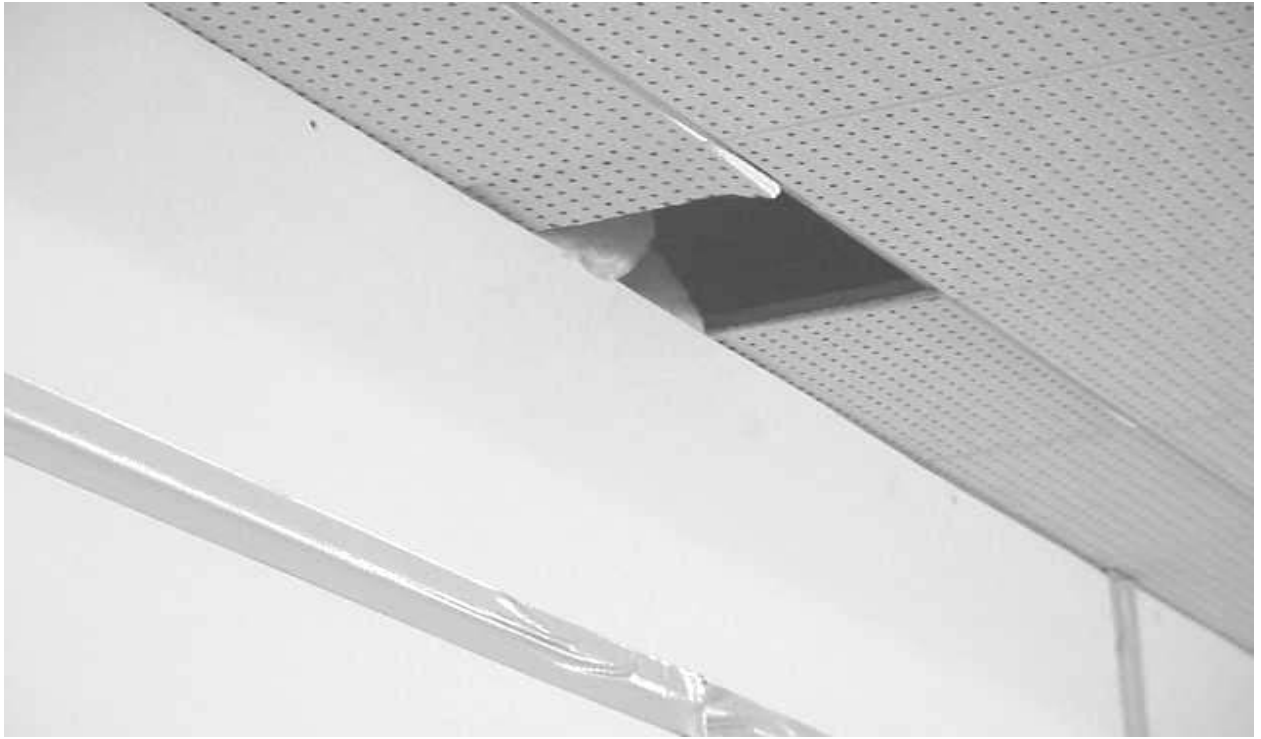
Picture 5

Missing ceiling tiles were also noted in several areas, providing spaces between the decking and wall (see Picture 5) which can provide a means of egress for renovation generated pollutants to enter occupied areas. None of the open spaces created by the lack of ceiling tiles have been sealed to prevent air movement above the ceiling tiles (see Figure 1). Dust and debris can move with drafts from the unoccupied construction section to occupied areas.

Missing Ceiling Tile Noted in Classroom Adjacent to the Construction Zone

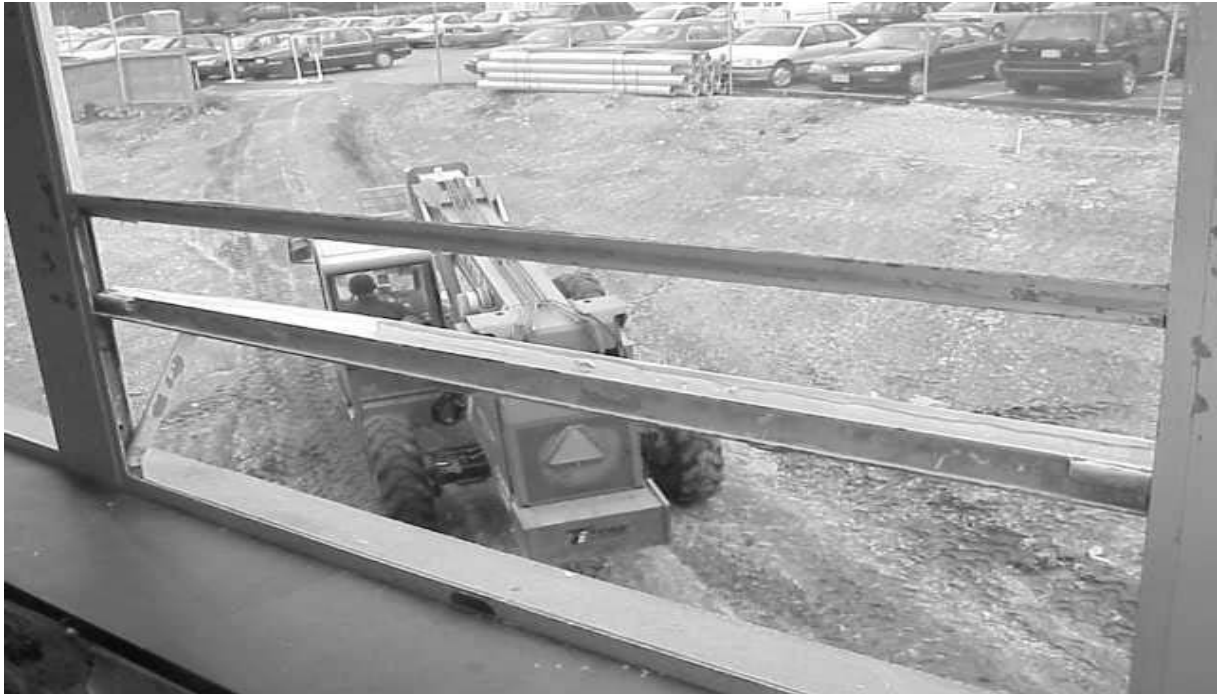
Picture 6

Located on the eastern side of the building is the parking lot for construction vehicles. Construction vehicles that run in this area can aerosolize amounts of dirt, dust and other particulates. Operating construction vehicles also produce vehicle exhaust, which contains carbon monoxide. A number of classrooms adjacent to this area were found with open windows (see Picture 6). Some of these rooms had deactivated univents. The open windows allow unfiltered outdoor air to enter the classroom environment that may transport airborne dirt, dust and particulates. In many classrooms, accumulated dirt and dust was observed on horizontal surfaces.

**Construction Equipment Operating outside East Side
Classroom with Open Window, Note of Loose Dirt**
(Picture Taken from Interior of Classroom)
